# **Tumwater Historic Brewery Site Study**

12 June 2015

# Tumwater Brewery Historic Site Redevelopment Brewhouse Seismic Improvements

Structural Narrative

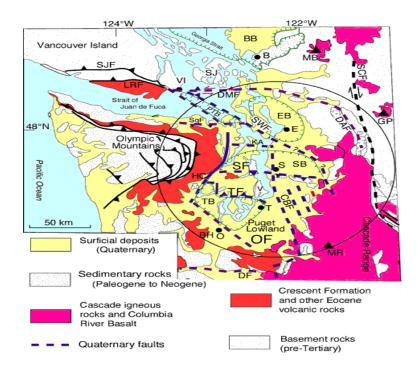
#### Figure 1: Earthquake Faults in Puget Sound

Western Washington is seismically active. Research indicates that there are three sources of strong ground motion in the Puget Sound region. The first is an interplate event off of the coast of Washington where the Juan de Fuca plate drives under (subducts) the North American plate. Earthquakes up to a Magnitude 9.0 and strong ground motion lasting several minutes are predicted from this source at intervals of approximately 500 years. The 1964 Alaska earthquake was caused by a similar mechanism. The second source is an intraplate event deep in the Juan de Fuca plate directly beneath Puget Sound. This event is thought to be capable of producing a Magnitude 7.5 earthquake with strong ground motion lasting 20 seconds once every 500 years. Our recent earthquakes, the 2001 Nisqually Earthquake (Magnitude 6.8), the 1965 SeaTac Earthquake (Magnitude 6.5), and the 1949 Olympia Earthquake (Magnitude 7.1), are examples of this type of event. The third source is a crustal event, which may occur along known or unknown fault lines. Figure 11, courtesy of the USGS "Seismic Hazards Investigation in Puget Sound" research program (http://earthquake.usgs.gov), illustrates major known crustal fault lines in the Puget Sound area. Since these shallow earthquakes are much closer to the surface, ground motions are expected to be very intense producing a Magnitude 7+ event with 20 second of strong ground motion. While the Tumwater Historic Brewhouse has survived the three major Puget Sound earthquakes of the last century without collapse this is no guarantee of future performance; the ground shaking on in these past earthquakes was comparatively light with likely ground accelerations less than 1/5<sup>th</sup> of design level ground motions.

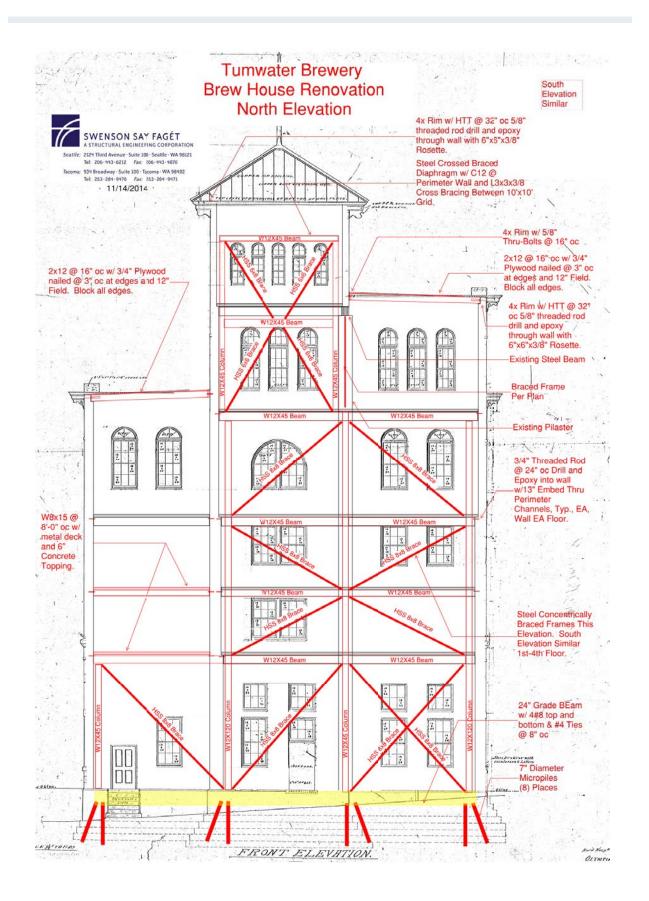
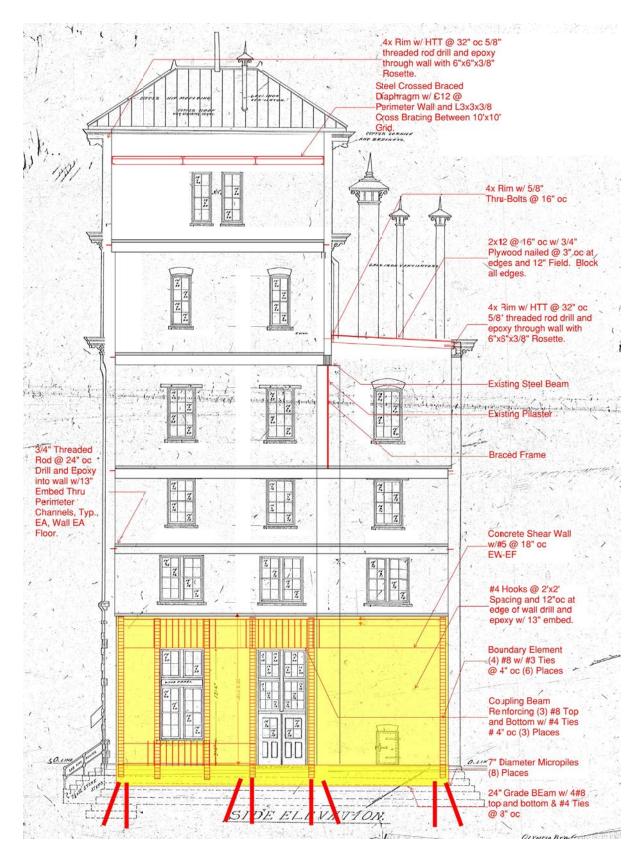
# Tumwater Brewery Seismic Retrofit Plan

The attached structural repair plan by Swenson Say Faget outlines a method for reinforcing the unreinforced masonry structure. They suggest an interior steel frame with new steel at floors and cross members between floors. The new frame would be secured to the masonry walls to ensure that the tower stands and masonry stays put during a seismic event. The structural repair would be installed in conjunction with a new roof structure, new roofing & gutters/ downspouts, comprehensive masonry and mortar repair, and restored and new exterior windows & doors. This is the minimal work required to preserve the structure for future generations.

- Portions of the building masonry wall structure have adequate strength to resist earthquake in-plane lateral load while other portions will require strengthening to resist lateral loads. Strengthening of existing walls can take the form of installation of steel braced frames or through the installation of a reinforced concrete facing to the wall. Steel braced frames would be installed on the interior of the building adjacent to the wall and portions of the steel framing would be bolted to the existing wall to deliver the wall lateral loads to the braced frames. For walls requiring a concrete facing, the concrete would be placed directly over the existing masonry at the interior of the wall. Steel reinforcing bar dowels would be drilled and epoxied into the masonry to anchor the wall to the reinforced concrete facing.

- Missing or damaged roof and floor diaphragms must be repairing in order for the existing masonry walls to have adequate wall out-of-plane bracing in these areas. In some areas of the building, we recommend infilling openings in existing floor diaphragms or adding floor diaphragm structure to limit the height of unsupported walls and reduce the potential for wall out-of-plane failure.

- The Brewhouse building is constructed on wood piles due to the presence of compressible or liquefiable soils beneath the building. Liquefiable soils are soils that are fully or partially saturated and that can lose strength under applied stress such as earthquake ground shaking. We believe that the soils under the building offer inadequate strength to transfer the building horizontal seismic forces at the foundation level. Further, we believe that the existing wood piles do not have adequate strength to resist both the vertical and horizontal foundation seismic forces. We recommend installing drilled micropiles at the foundation perimeter to mitigate the foundation deficiencies. Micropiles are small diameter drilled shafts with a central high strength reinforcing bar. The micropiles would be drilled to a depth sufficient to engage competent soils that are neither compressible nor liquefiable. A combination of straight and batter piles would be installed to resist the vertical and lateral seismic forces.

Following is a summary of findings and retrofit recommendations based on our ASCE 41-13 evaluation of the Brewhouse building. Please see the schematic seismic retrofit plan and building elevations at the end of this report for a more detailed description of the recommended retrofit measures. Implied but not explicitly described or detailed is the need for restoration of the existing masonry walls including replacement of damaged or missing brick and repair and repointing of the masonry mortar joints. This work should be completed in conjunction with the recommended work outlined below.

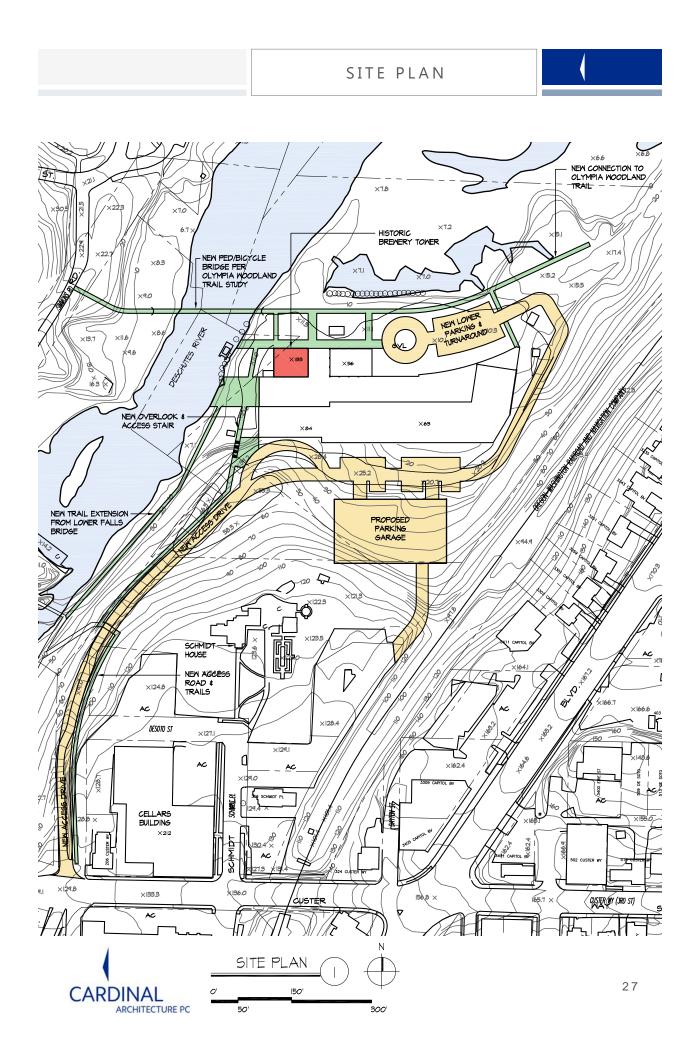
All of the proposed new construction for this study is shown on the attached site plan, and additional information is included on civil engineering drawing from Sitewise Design, and landscape architecture drawings from JKLA. We limited the scope of work to that described above, and are not including the additional historic structures adjacent to the Historic Brewery Tower or additional structures that could be proposed for the site.

The proposed new access road would essentially follow the existing access road, and would be a new 22' wide, 2- lane asphalt concrete road. To create the wider road, the road would cut into the existing hill and be supported with new retaining walls. In addition, for the upper road, a walking path would be added to the road width to provide pedestrian access from Custer Way down to the site. The path would switch to the west side of the road, where it would meet with existing trails along the river. The road would wind down the slope to the historic buildings then turn east to wrap around the buildings and would end at a turn-around on the north side of the historic structures.

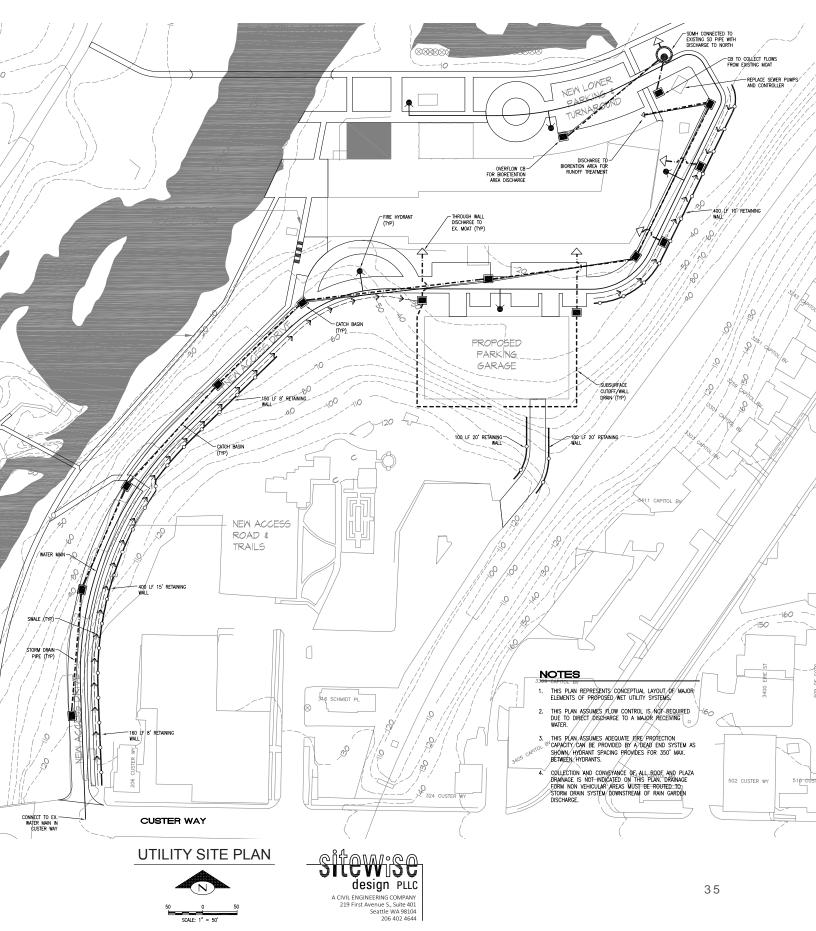
#### UTILITY SITE PLAN

In addition to the construction of the access road, the study recommends including new wet utility systems below the new roadbed. Storm water control would be required for the road construction, and new water and sewer would be required for any new proposed development at the historic site.
