PHASE I ENVIRONMENTAL SITE ASSESSMENT
OLD BREWHOUSE
3245 BOSTON STREET S.W.
TUMWATER, WASHINGTON

**PHASE I ENVIRONMENTAL SITE ASSESSMENT
OLD BREWHOUSE
3245 BOSTON STREET SW
TUMWATER, WASHINGTON**

February 1997

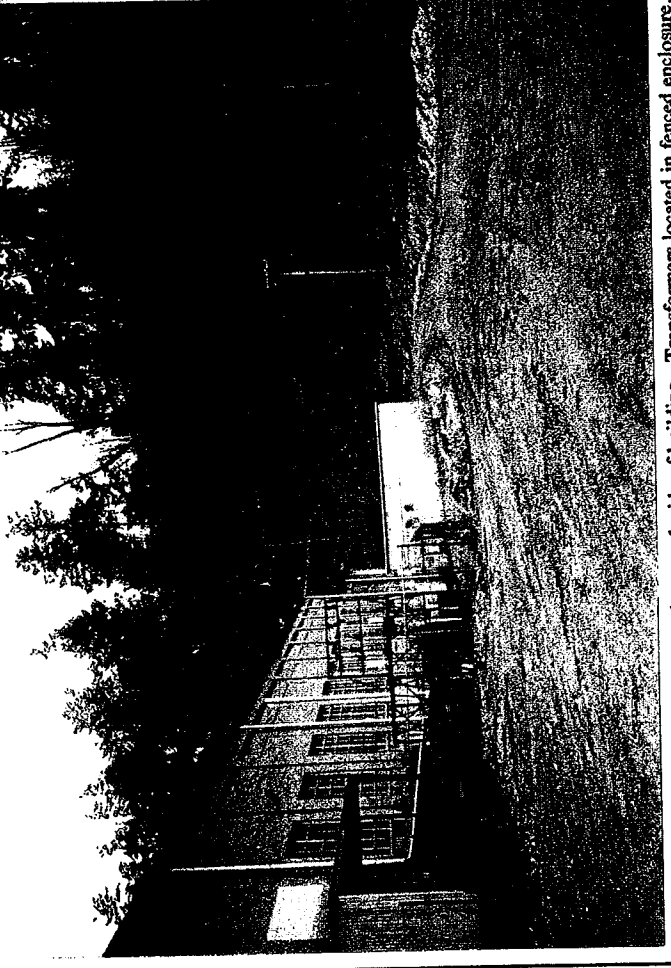
4. View looking east down access road on south side of building. Transformers located in fenced enclosure.

PCBs. The warehouse complex is serviced by six transformers that are located in a fenced enclosure on the south side of the building. The transformers were purchased used from the Puget Sound Power and Light Company in September 1986 (Puget Sound Power & Light Company 1986). The transformers reportedly were tested prior to their sale and found to free of PCBs (Eckloff, D., 14 January 1997, personal communication).

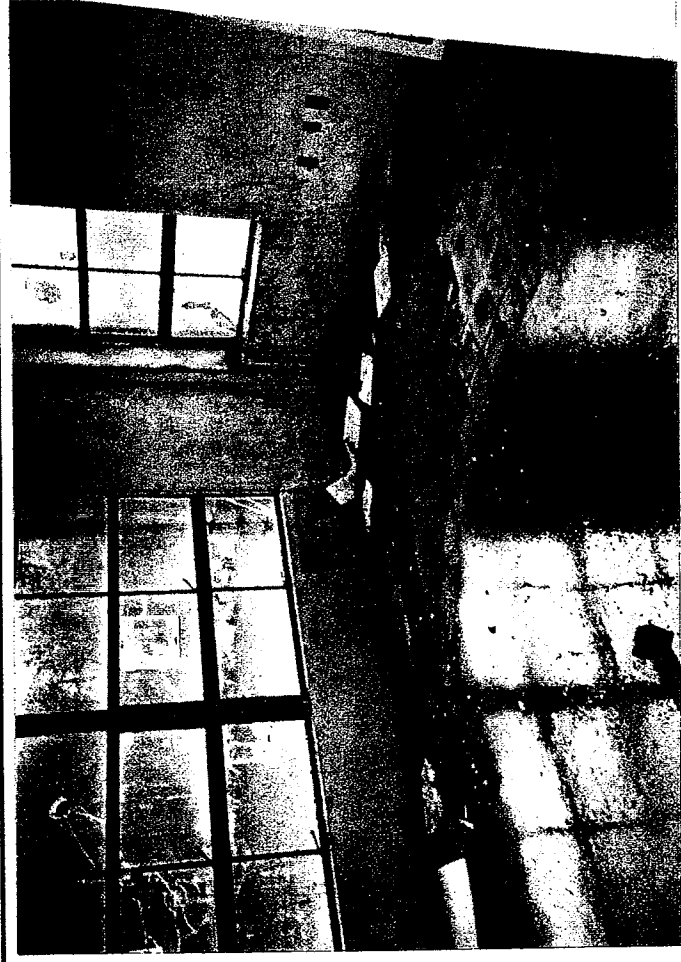
11. View of office on second floor of five-story west addition. 9-inch asbestos tiles on floors throughout.

- The five-story office structure adjacent to the south warehouse bays contains 9-inch vinyl floor tiles and mastic found on the second and third floors;

The 9-inch floor tiles found in the former offices are in poor condition and are delaminating from the substrate due to water damage. The sheet vinyl flooring in the office area near the gift shop is in poor condition and is delaminating from the wood substrate. The insulation around the boiler pipe that is visible through the pipe chase appears to be in good condition. However, the ends of the insulation are exposed at the face of the pipe chase. The built-up roof of the single story structure appears to be intact and in good condition.

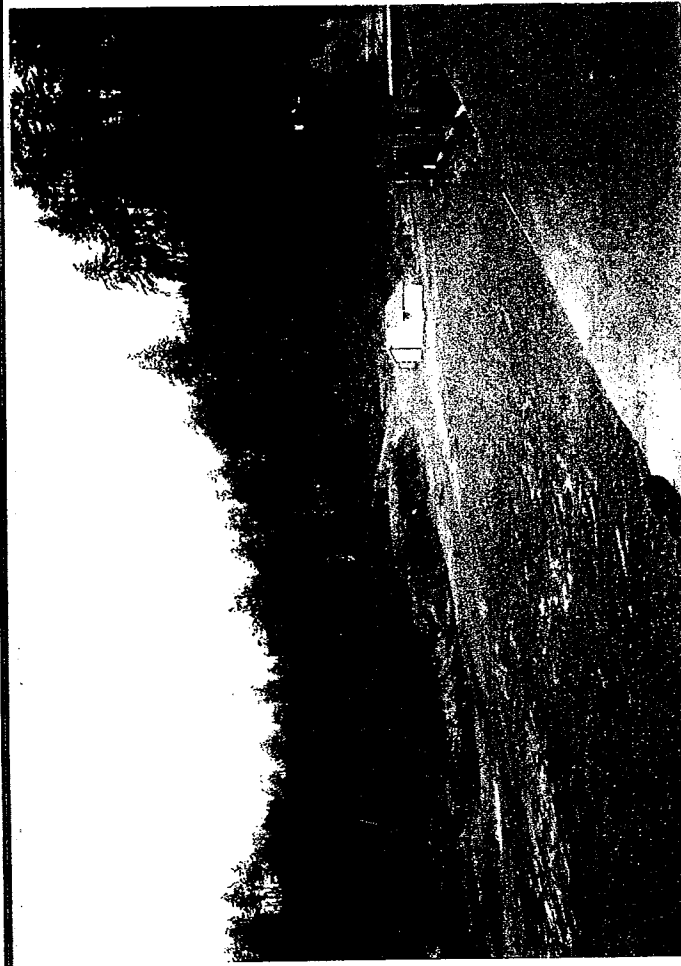
13. View from one-story roof looking northeast toward sewage pump station. Graded debris area to the left.

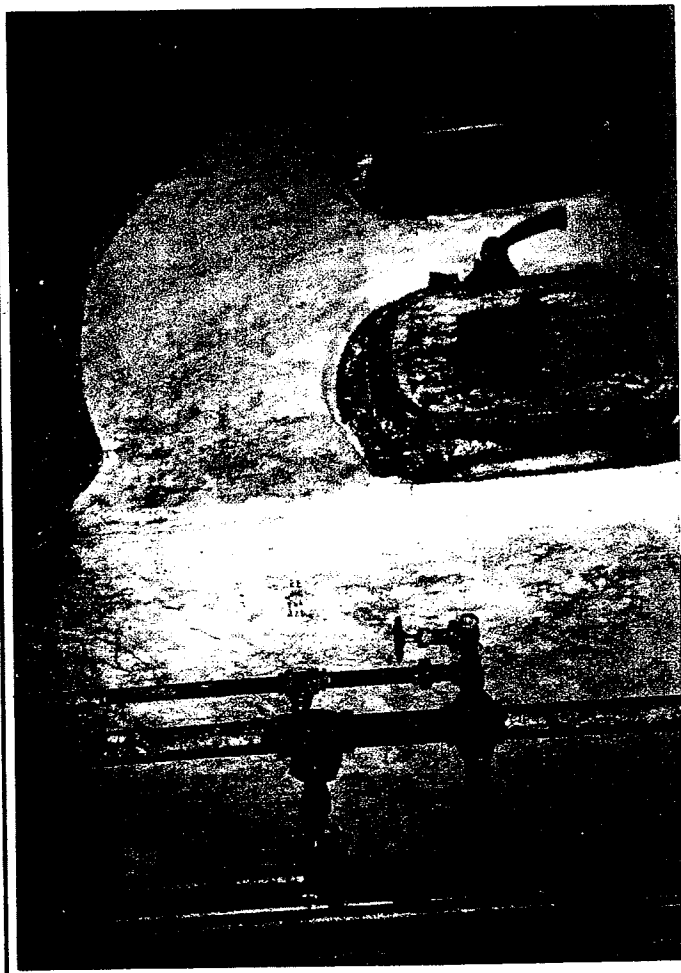
19. View of inactive boiler that is covered with asbestos insulation. Pipe into warehouse covered w/asbestos.

- The boiler and associated piping are covered with a thick insulation blanket of magnesium silicate which historically has tested positive for asbestos. The insulation material is in fair condition but is susceptible to further deterioration.

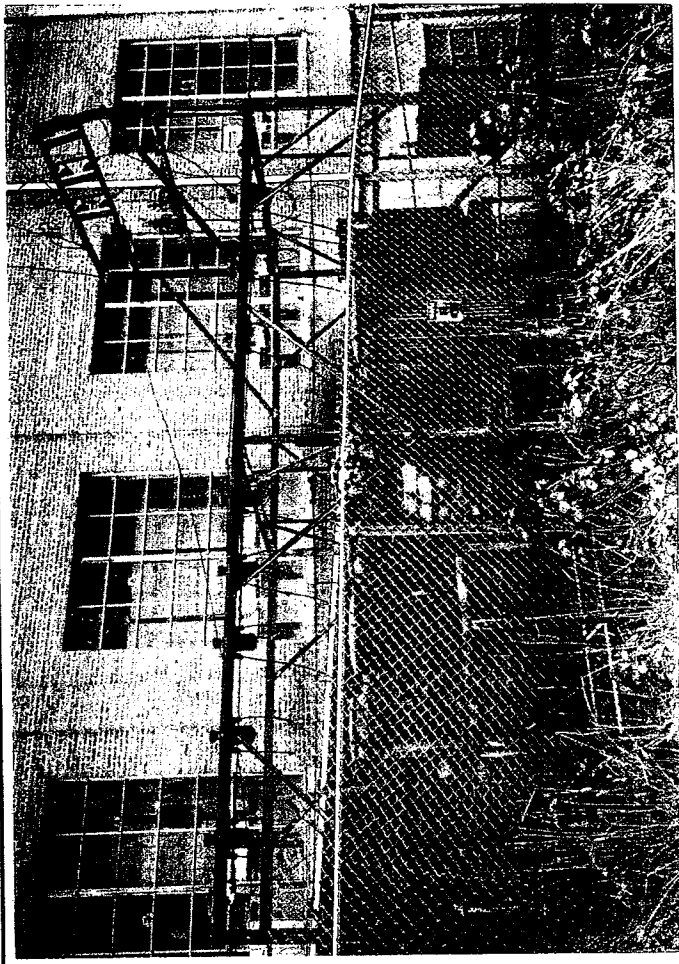
20. Bank of transformers on south side of building. Purchased in 1986 from Puget Power, non-PCB oil.

- The used transformers that were purchased from Puget Sound Power and Light Company in 1986 reportedly tested negative for the presence of PCBs. It is recommended that Pabst Brewing Company provide corroborating documentation, either from Puget Sound Power and Light Company or the laboratory that conducted the testing, that confirms the absence of PCBs from the transformers. In the event that these transformers are determined to contain PCBs, or in the absence of supporting documentation regarding PCB content, the current transformer storage area would not be in compliance with the requirements of the Toxics Substance Control Act (40 CFR 761).
