GEOTECHNICAL REPORT

**Port of Olympia Property
76th Avenue Southwest and Center Street Southwest
Tumwater, Washington**

Project No. T-8388

**Draft September 22, 2020
Revised January 31, 2022**

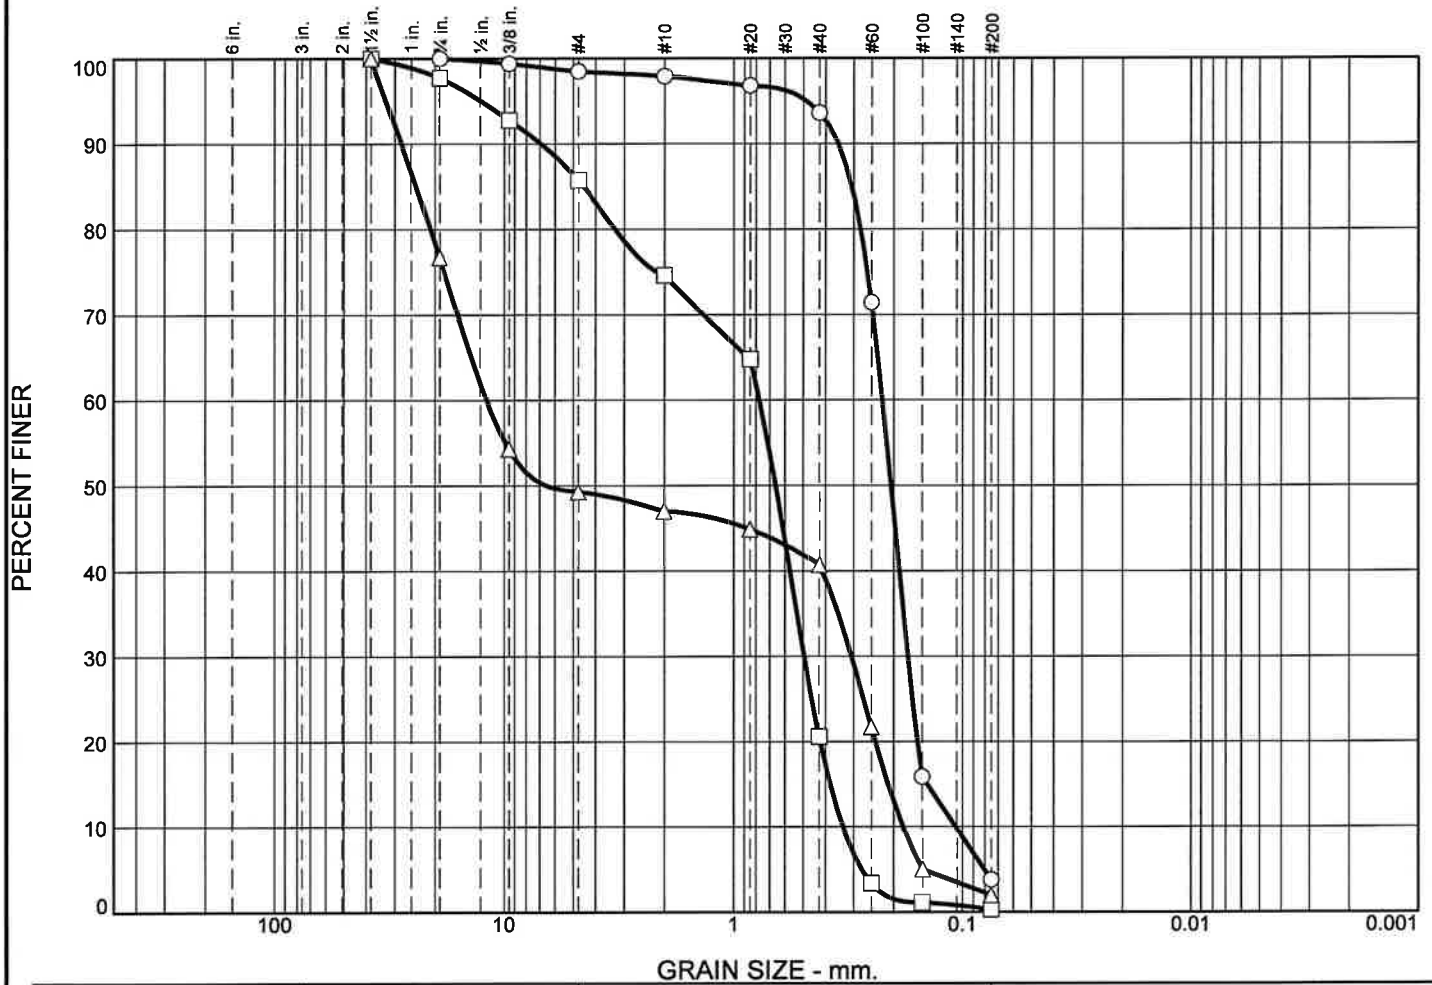
Particle Size Distribution Report

% +3"	% Gravel		% Sand			% Fines	
		Coarse	Fine	Coarse	Medium	Fine	Silt	Clay
○	0.0	0.0	1.5	0.6	4.3	89.8	3.8	
□	0.0	2.3	12.0	11.1	54.0	20.3	0.3	
△	0.0	23.3	27.4	2.3	6.3	38.7	2.0

LL	PL	D ₈₅	D ₆₀	D ₅₀	D ₃₀	D ₁₅	D ₁₀	C _c	C _u
○			0.3064	0.2235	0.2050	0.1730	0.1425	0.1070	1.25	2.09
□			4.5242	0.7727	0.6584	0.4945	0.3799	0.3340	0.95	2.31
△			24.1325	11.8768	6.5174	0.3066	0.2105	0.1819	0.04	65.30

Our recommended preliminary infiltration rate was derived using grain size distribution results for samples from Test Pits TP-11, TP-14, and TP-29, and methods outlined in the 2018 City of Tumwater Drainage Design and Erosion Control Manual. The calculation is also based on a minimum separation distance of three feet between the base of the infiltration facility and design high groundwater levels. The preliminary design infiltration rate incorporates correction factors recommended in the manual.
