WETLAND, AND FISH AND WILDLIFE HABITAT ASSESSMENT REPORT

PORT OF OLYMPIA-SOUTH SOUND COMMERCE CENTER

DECEMBER 2021

7380 LINDERSON WAY SOUTHWEST, TUMWATER, WA 98501

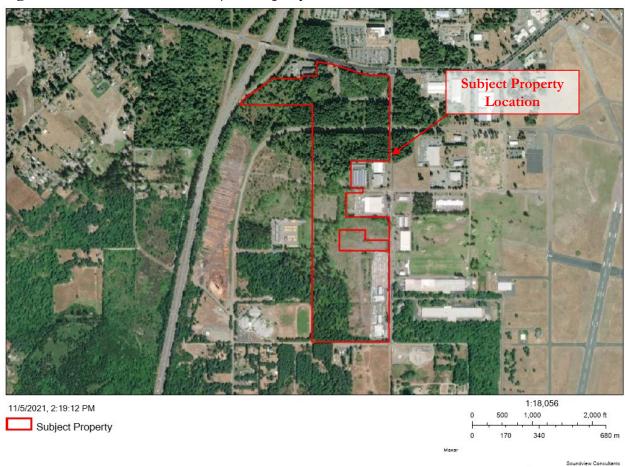
Figure 2. Aerial View of the Subject Property

The subject property is located in a mixed land use setting in the City of Tumwater. The subject property is adjacent to industrial facilities to the north, Olympia Regional airport and industrial facilities to the east, single family residential units to the south, and a mix of undeveloped land, log yard operations and schools to the west. The portion of the property proposed for development is currently manipulated by the presence of gravel pads and access roads likely used to support historic log yard operations onsite. The northern and southern portion of the property remains largely undeveloped and forested, apart from the additional gravel yards and access roads identified throughout the site. The subject property is located within Water Resource Inventory Area (WRIA) 23 – Upper Chehalis and 13 - Deschutes. The site is generally flat aside from a series constructed hummocks (spoils piles) and drainage swales located throughout the property. A USGS Topographic map is provided in Appendix B1.

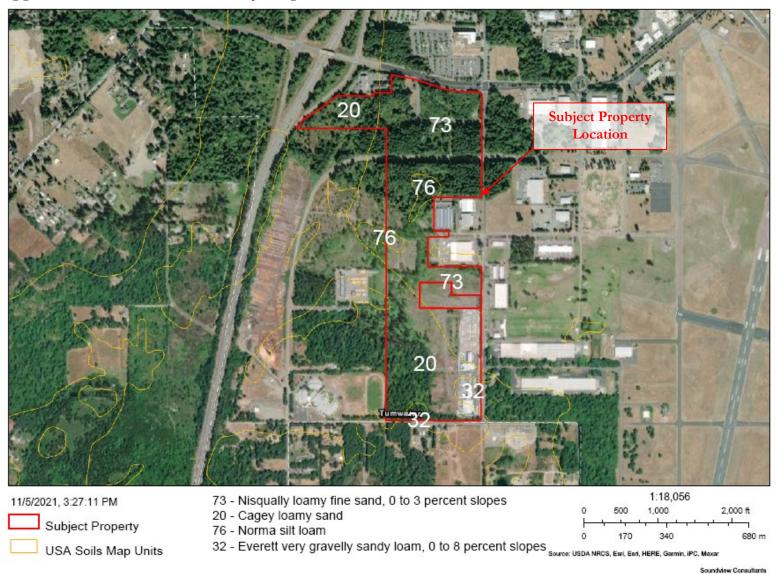
Appendix B2. NRCS Soil Survey Map

The NRCS Soil Survey of Thurston County, Washington identifies four soil series present on the subject property: Everett very gravelly sandy loam, 0 to 8 percent slopes (32), Cagey loamy sand (20), Nisqually loamy fine sand, 0 to 3 percent slopes (73), and Norma silt loam (76). A soil map is provided in Appendix (B2).

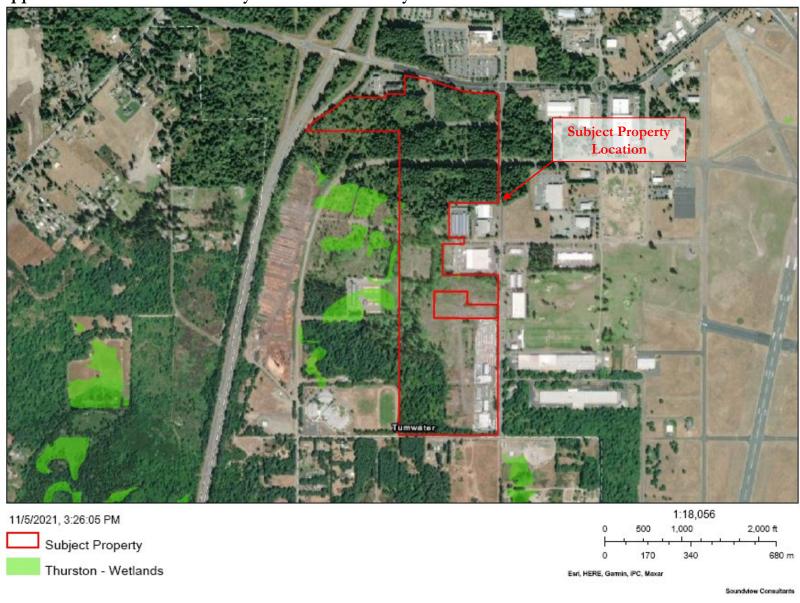
Appendix B3. Thurston County Wetlands Inventory

Thurston County potential wetland polygons within 300 feet of the proposed parking area that extends offsite minimally, were represented by DP-1U, DP-7U, DP-8U and DP-9U. None of these data plots met all three wetland criteria. DP-1U failed to meet all three criteria, whereas DP-7U and DP-8U did support a hydrophytic plant community due to the presence of common facultative species, but lacked hydric soils and wetland hydrology. DP-9U also showed evidence of a hydrophytic plant community due to the presence of common disturbance tolerant species, but also exhibited hydric soils meeting

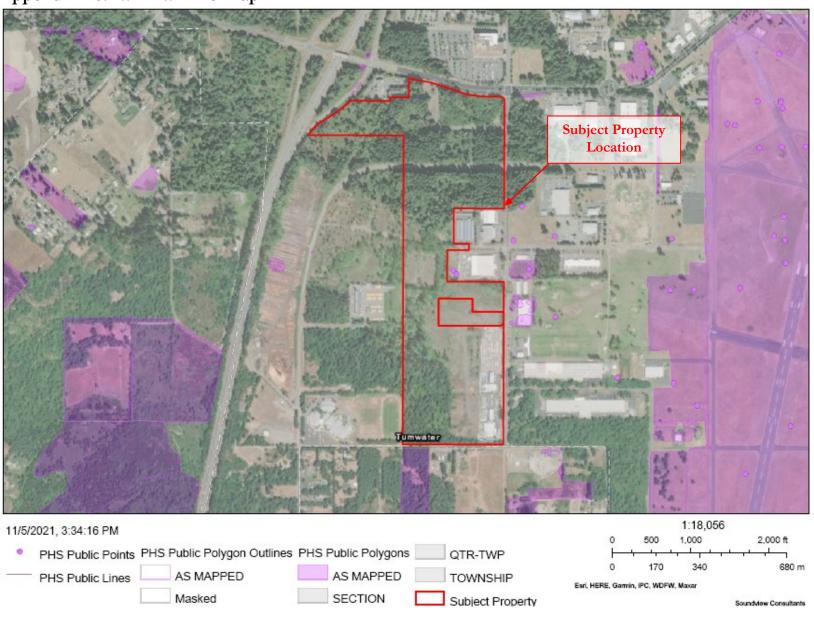
Appendix B6. WDFW PHS Map

In addition, the WDFW PHS map identifies distinct populations of the Oregon vesper sparrow (Pooecetes gramineus affinis), and Mazama pocket gopher (Thomomys mazama) within 330 feet of the site. The documented locations of the Oregon vesper sparrow are noted within 100 feet of the project area; however, it is likely the species exists over 330 feet from the subject property. PHS data for the Oregon vesper sparrow places accuracy of documentation at a quarter of a mile and notes the most recent documentation is from 2015. It is likely the presence noted near the site would actually belong to a known and well-established Oregon vesper sparrow population known to nest and inhabit the northern extent of the Olympia Regional Airport. All priority species including big brown bat, Townsend's big-eared bat, Oregon vesper sparrow, and Mazama pocket gopher have been thoroughly assessed in the Habitat Conservation Plan (HCP) under a separate cover.

Occurence Name	Federal Status	State Status	Sensitive Location
Oregon vesper sparrow	N/A	Candidate	No
Mazama (Western) pocket gopher	Threatened	Threatened	No
Big brown bat	N/A	N/A	Yes
Townsend's Big-eared Bat	N/A	Candidate	Yes

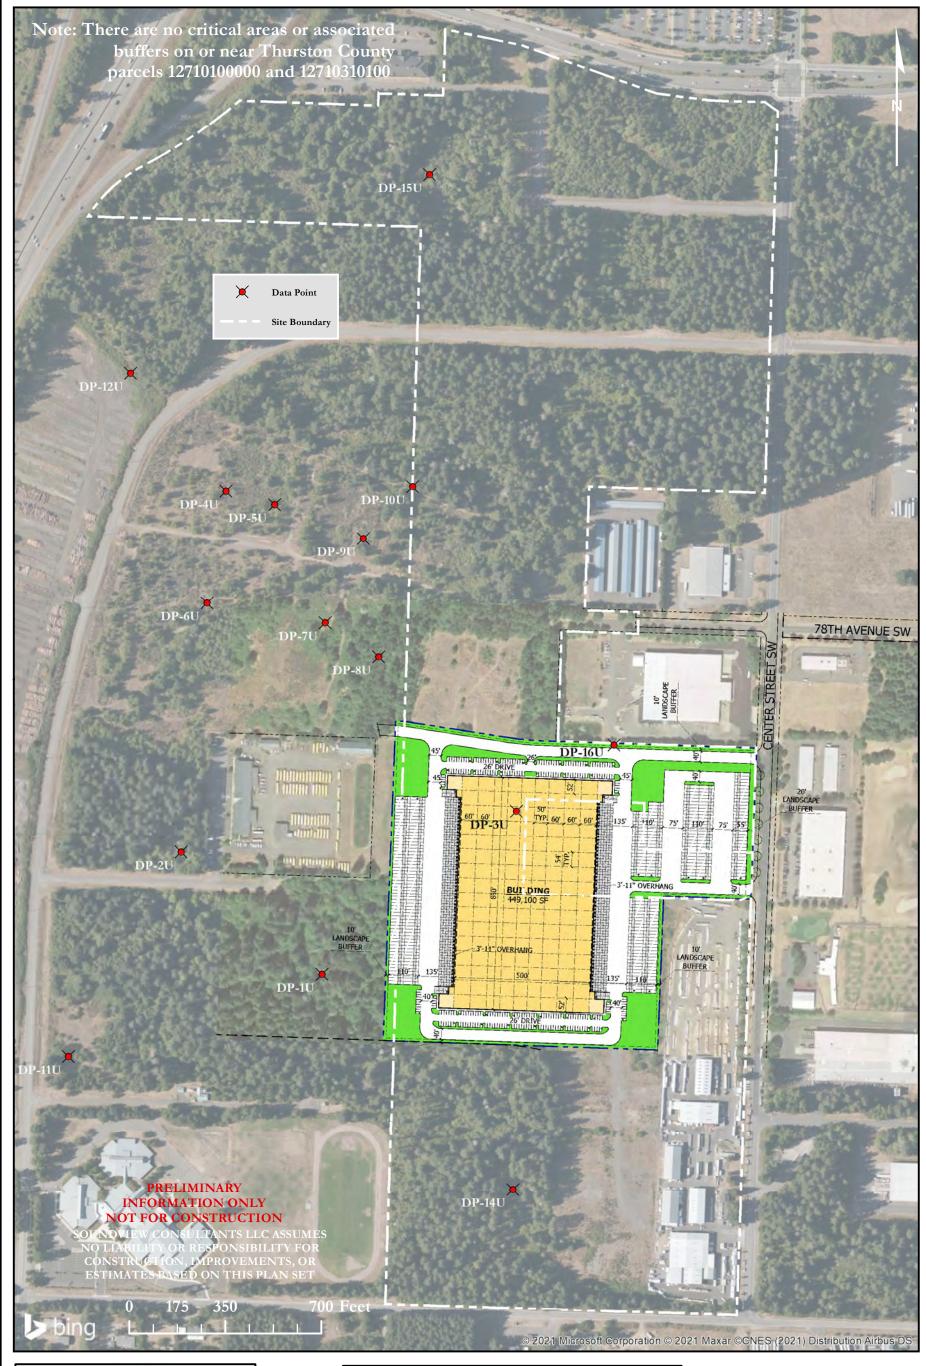
PORT OF OLYMPIA - SOUTH SOUND COMMERCE CENTER - PROPOSED PROJECT

The Applicant proposes to develop an industrial facility in the center of the subject property. The development will consist of a 449,100 square foot building surrounded by a right-of-way, parking facilities, landscaping, and associated infrastructure. All development will be located over 300 feet away from any critical aeras within the vicinity of the property. No wetlands, streams or critical area were observed onsite, and as such, it appears that industrial development of the subject property will not be encumbered by any potentially-regulated wetlands, fish and wildlife habitat, and/or associated buffers.
