**DETERMINATION OF NON-SIGNIFICANCE  
(DNS) TUM-23-1260  
PSE BARNES LAKE SUBSTATION  
REBUILD/EXPANSION**

Description of Proposal: Rebuild and expand the Barnes Lake Substation to extend and increase the capacity and life of the sub-station to meet growing demand in the area.

Location of Proposal: 1697 2<sup>nd</sup> Ave SW, Tumwater, WA 98512. Parcel number 09080011003.

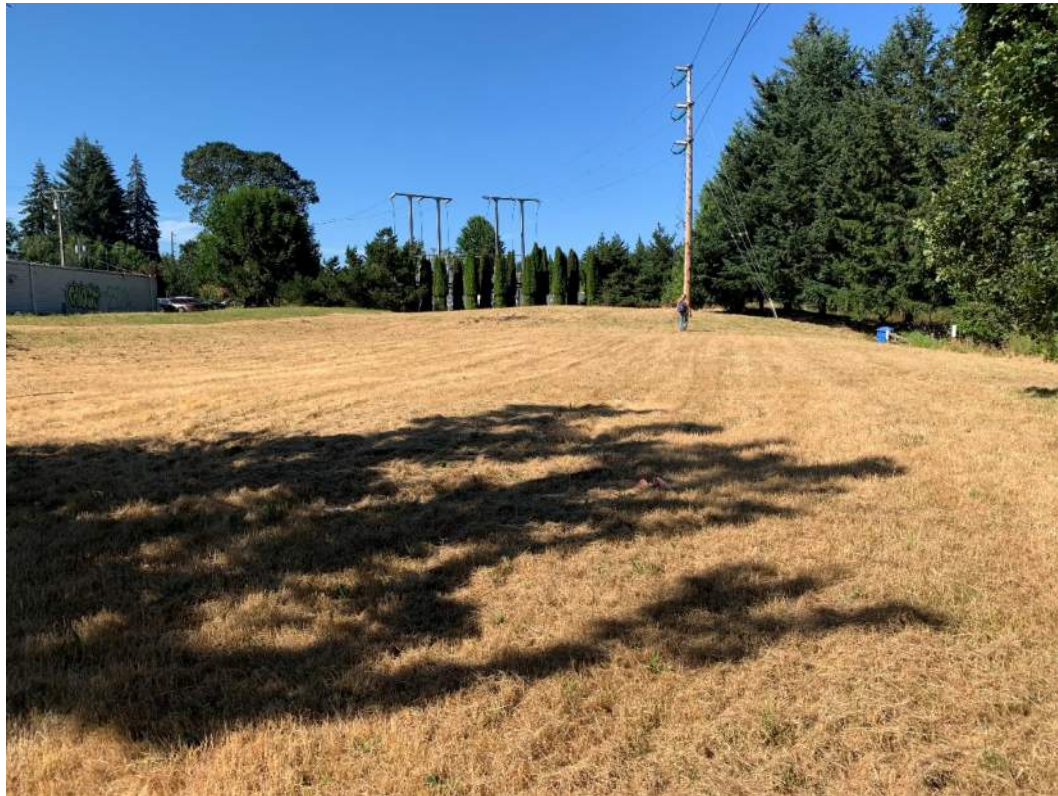
*Figure 1. Project parcel from the north end looking south toward the substation*

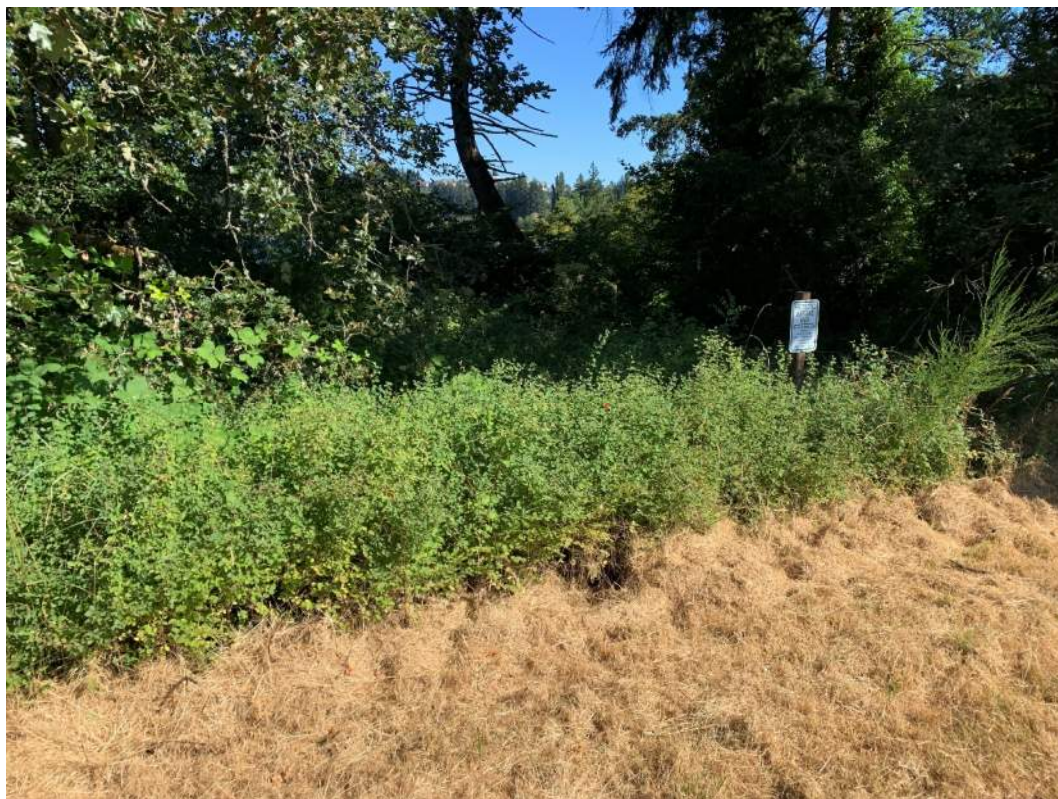
*Figure 2. Shrub fringe at northern edge of parcel, with Wetland Protection sign visible*

A fence and posts with Wetland Protection signs were observed northwest of the mowed area, with unmowed grasses and shrubs occurring on the north side of the signs. The Wetland Protection signs are assumed to be associated the United States Fish and Wildlife Service (USFWS) National Wetlands Inventory (NWI) mapped emergent wetland occurring on the fringe of Barnes Lake. No hydrophytic grasses were observed within the unmowed portion, and soils appeared light brown in color with no observed redoximorphic features. The shrub fringe occurring northeast of the unmowed grasses consisted of predominantly Facultative Upland (FACU) species such as snowberry (*Symphoricarpos albus*), oceanspray (*Holodiscus discolor*), and Oregon grape (*Mahonia nervosa*), with an oak (*Quercus garryana*) canopy. Soils appeared light brown in color with no observed redoximorphic features. No signs of wetland hydrologic indicators were identified in either the unmowed grass or shrub areas.

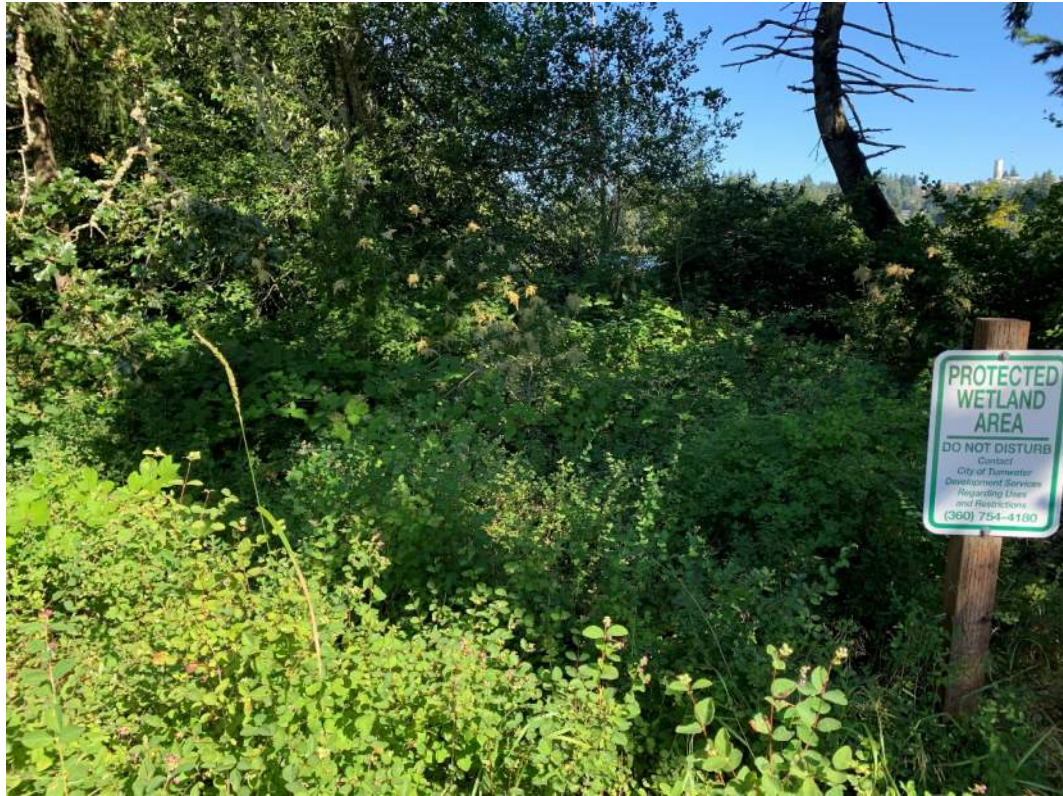
*Figure 3. Typical vegetation within the shrub fringe area- showing snowberry, oceanspray, and oak, with Barnes Lake visible in the background.*

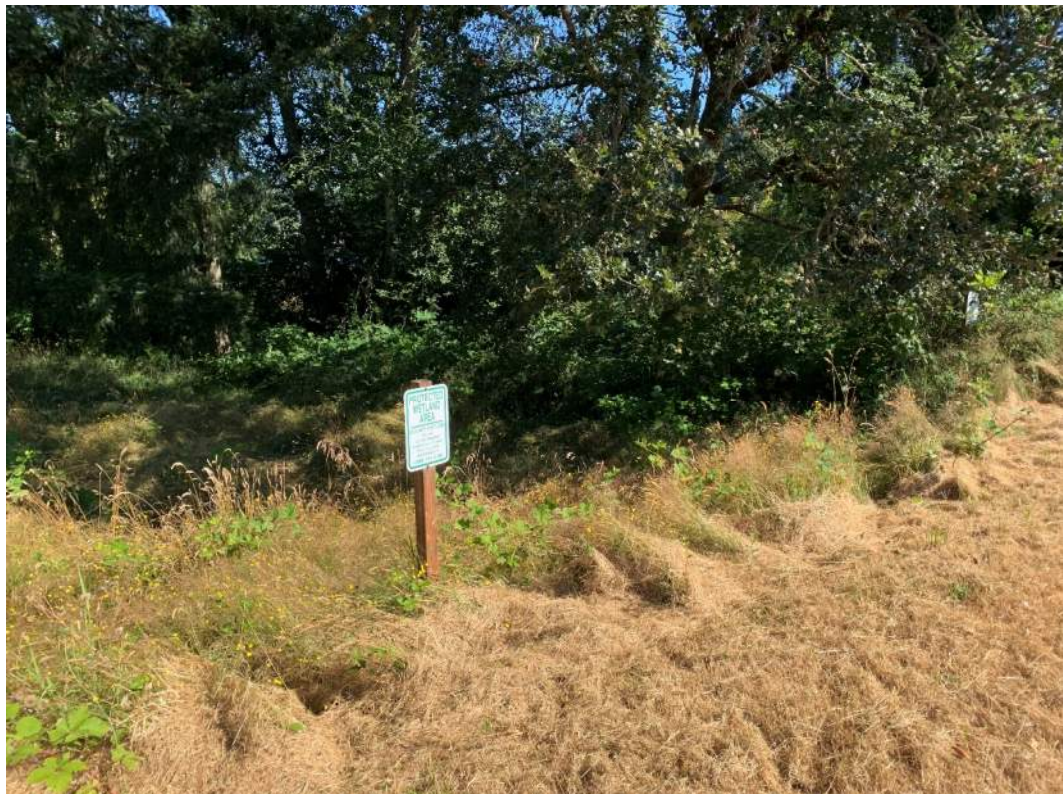
*Figure 4. Wetland Protection sign with unmowed grasses and a shrub fringe occurring beyond the sign.*

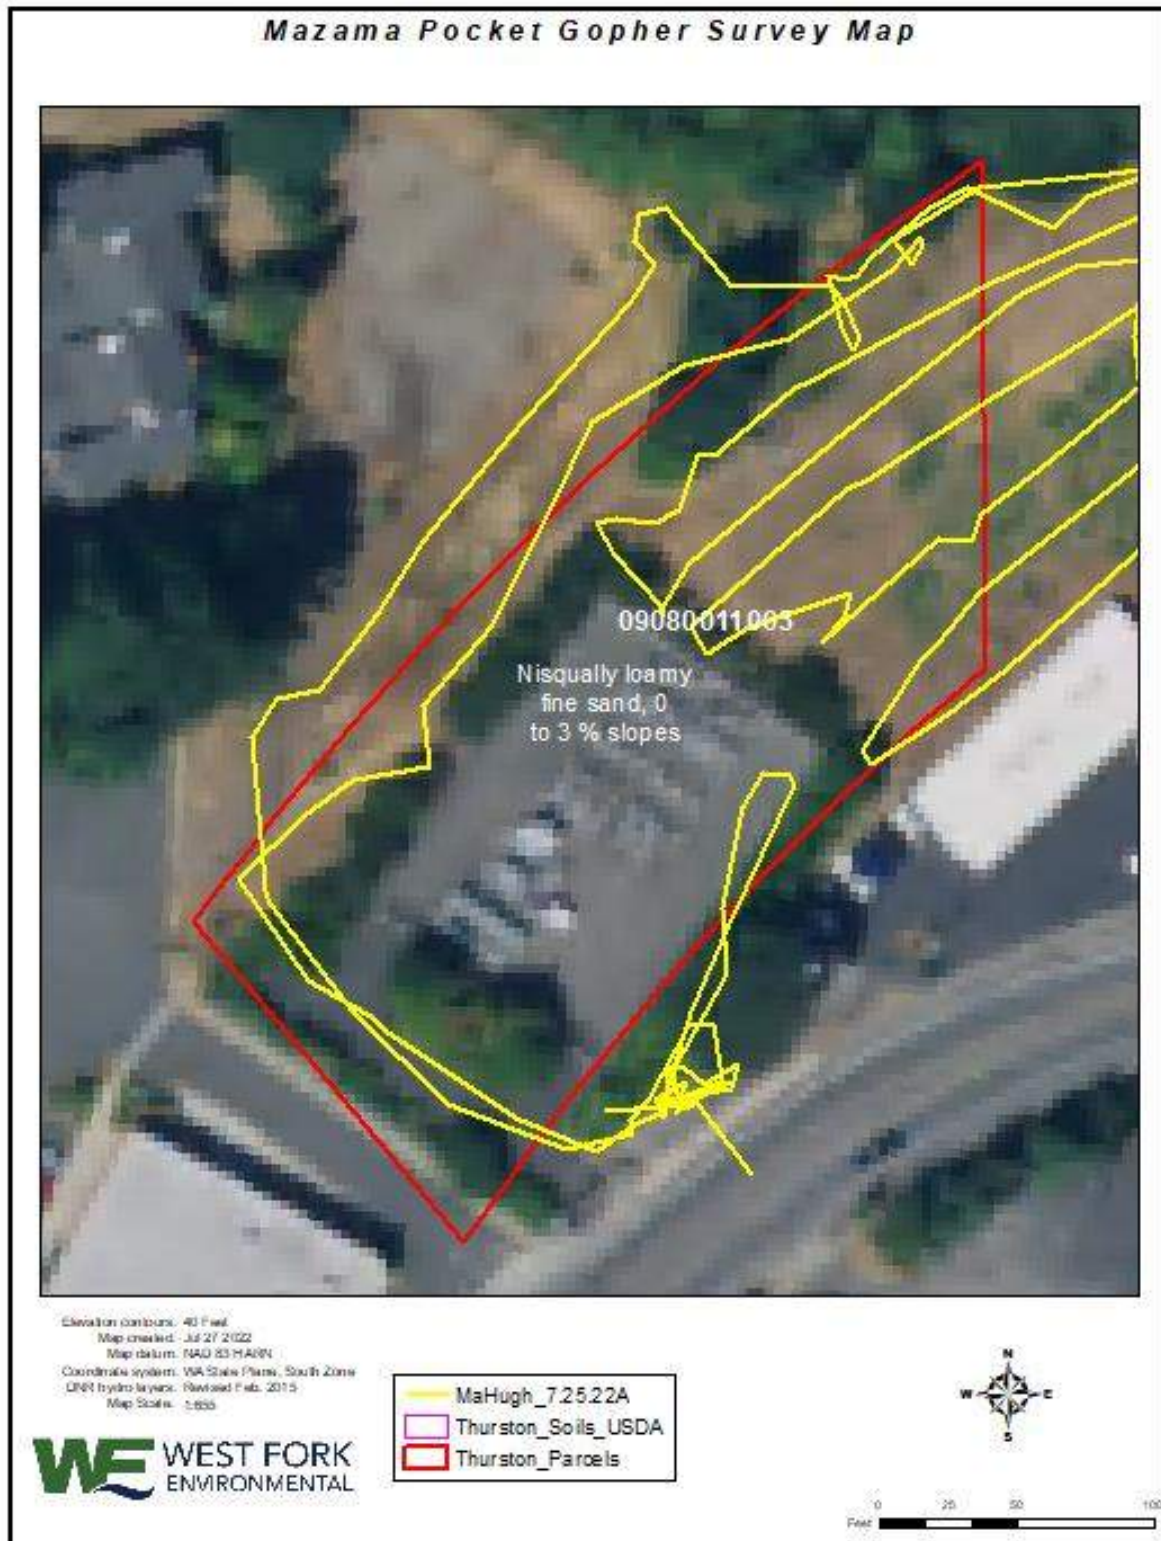
Figure 2. Survey tracks from July 25, 2022.

During the survey West Fork Environmental staff waled transects across all open areas of the parcel looking for mounds as described under the USFWS recommended MPG survey protocol (Figure 2-4). We did not have access to the secured substation area, but heavy gravel is present throughout and no potential MPG habitat was observed within the fence (see photos).

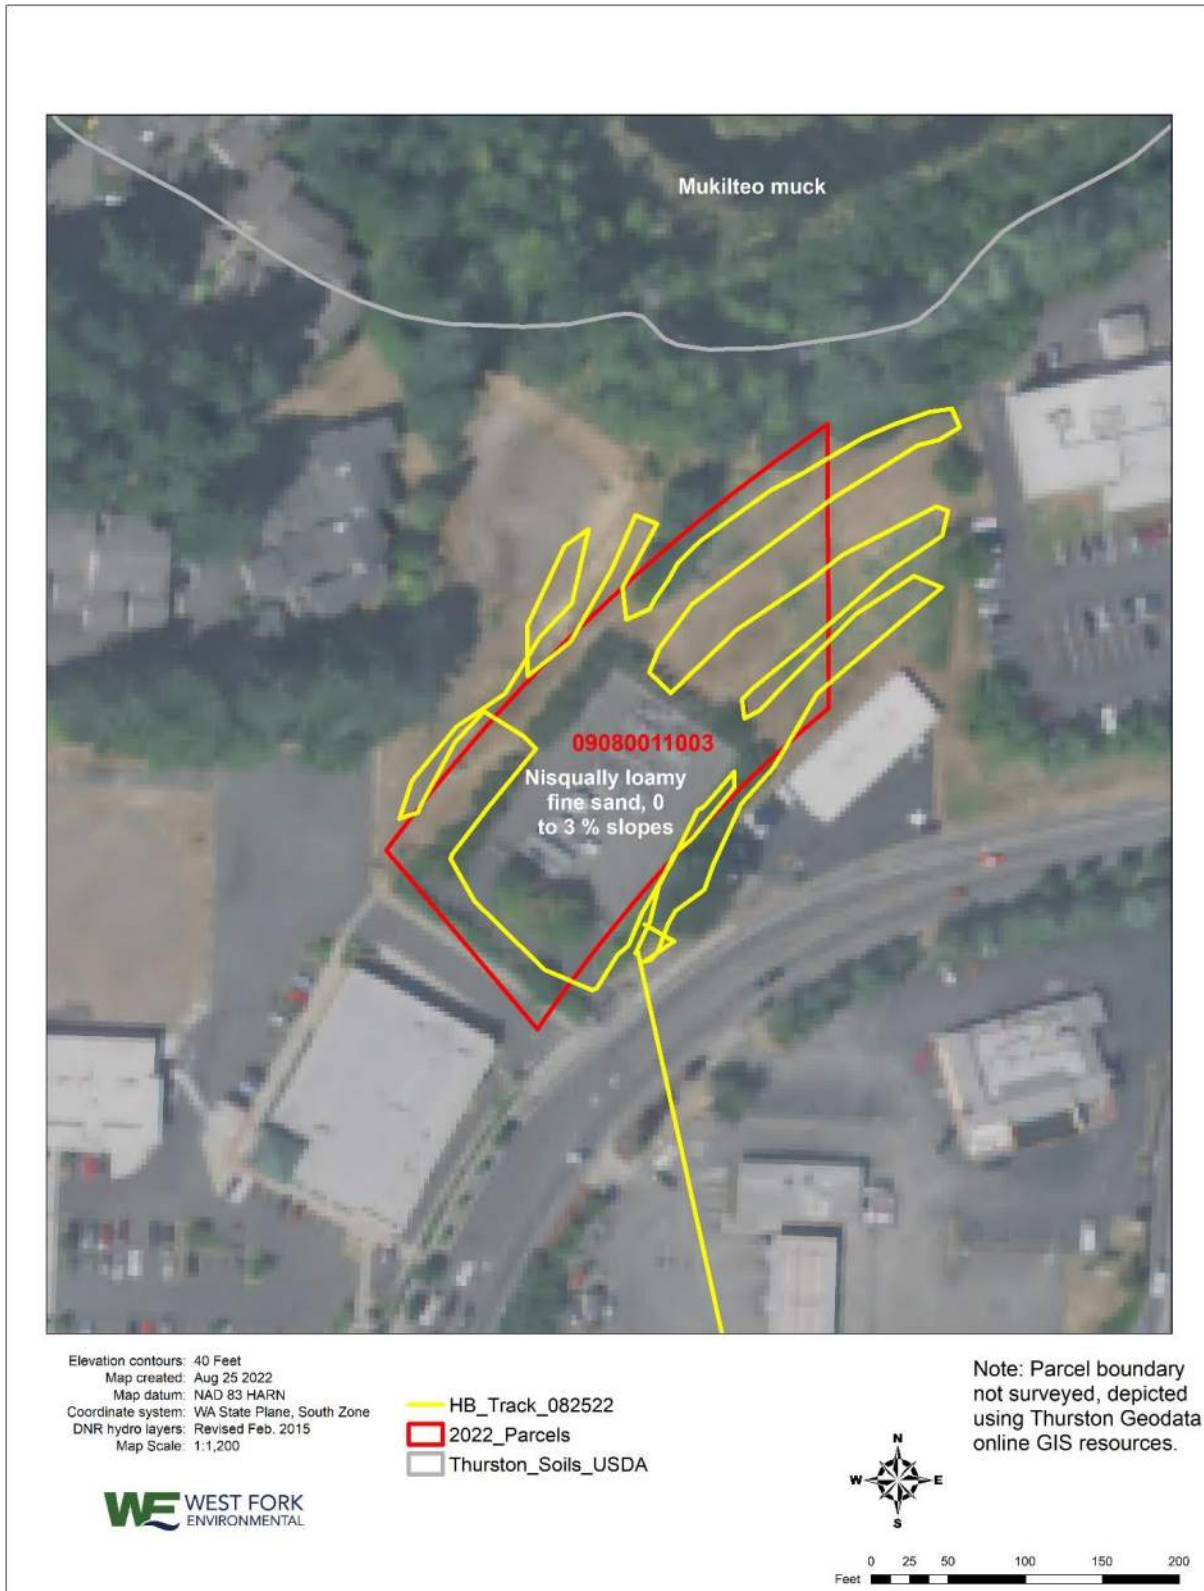
Figure 3. Survey tracks from August 25, 2022.

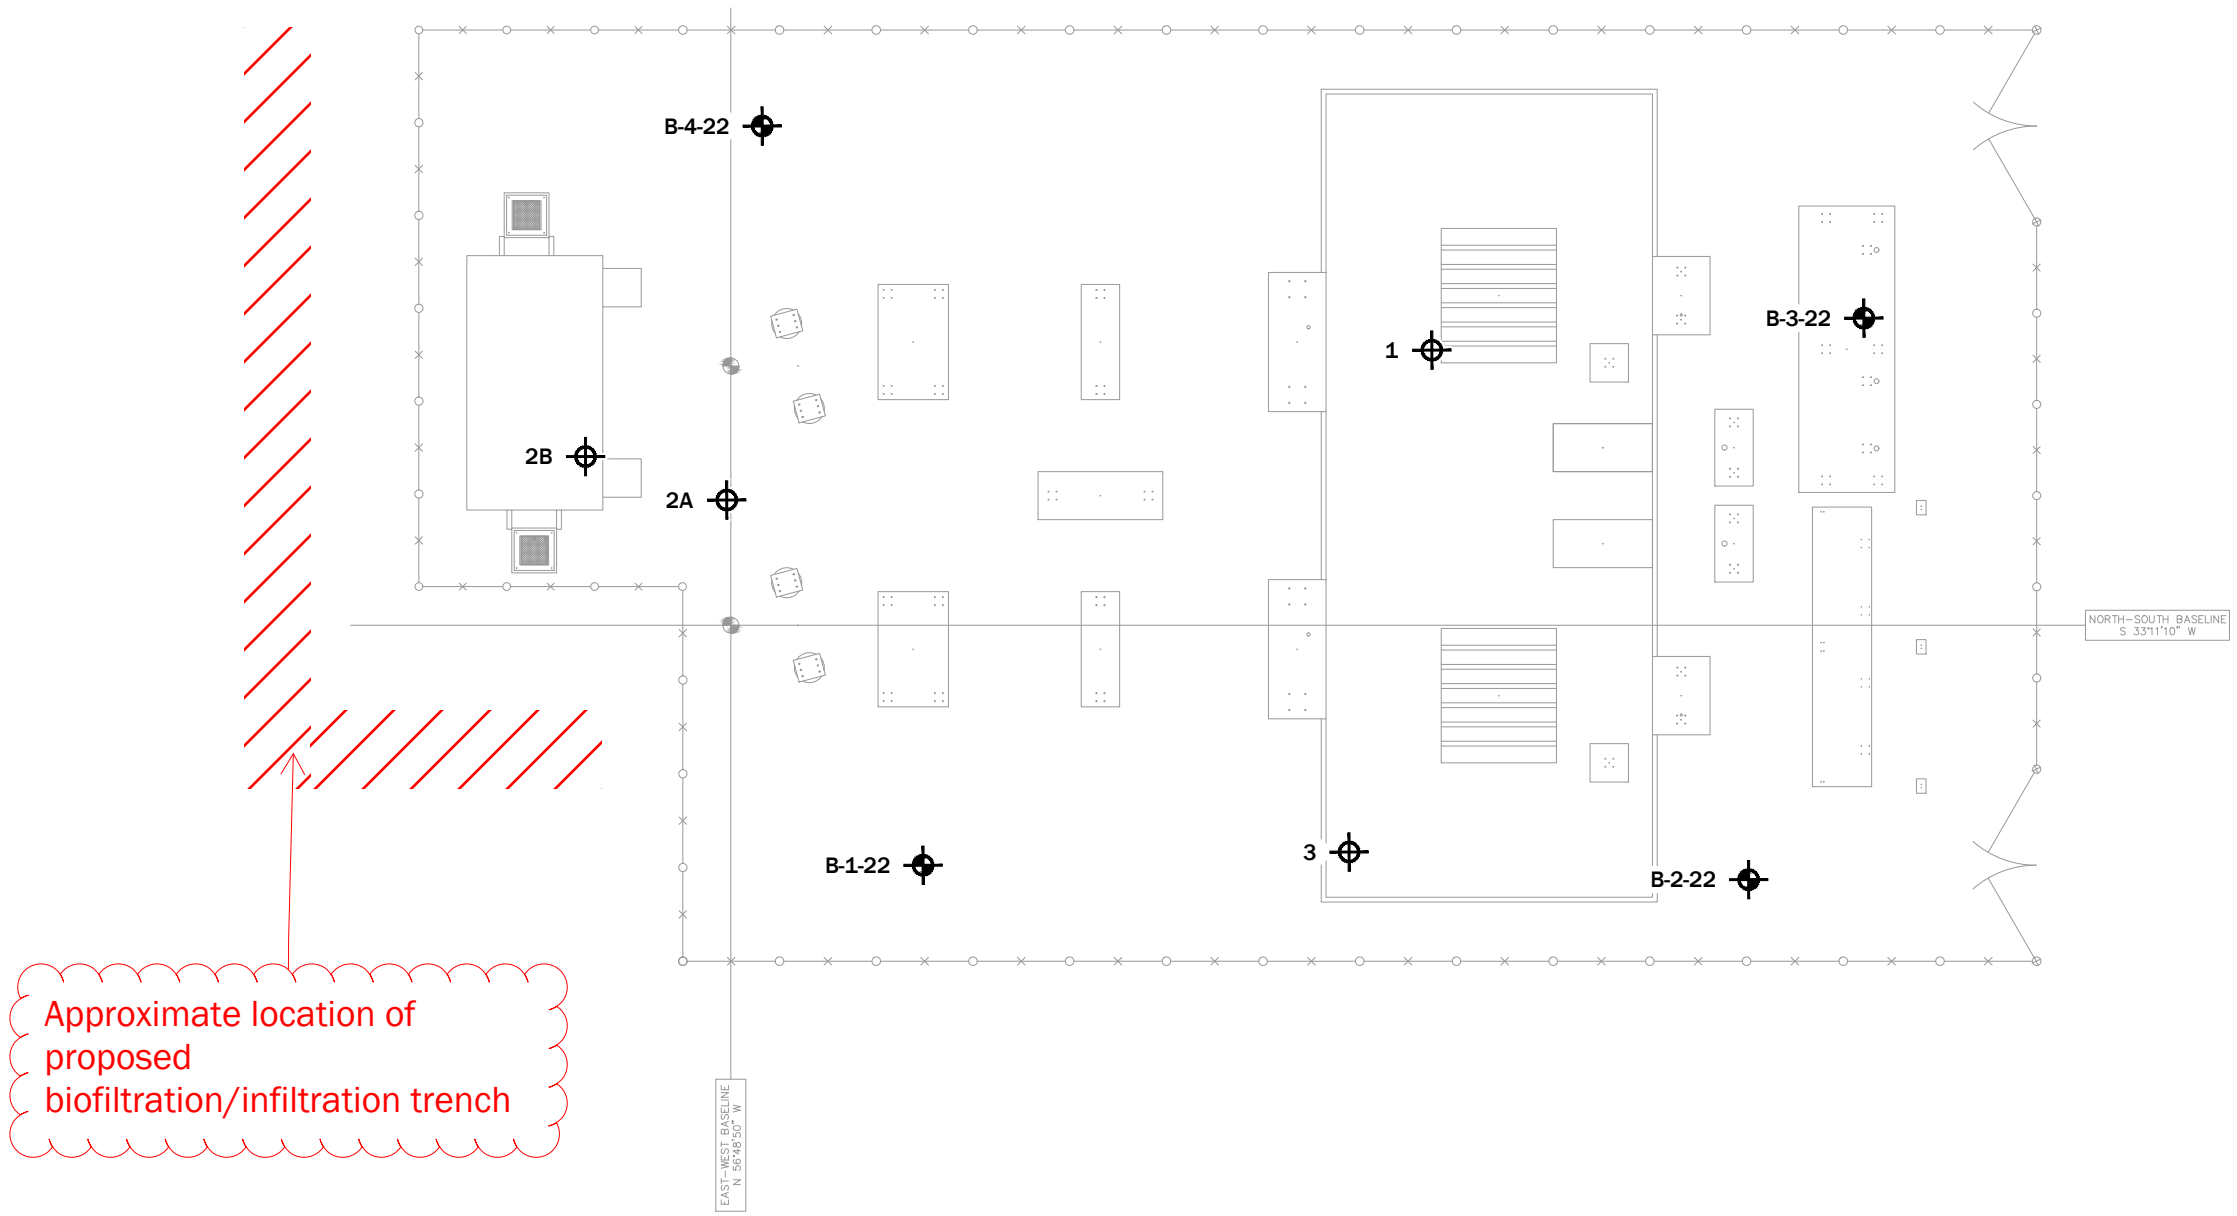
Approximate location of proposed biofiltration/infiltration trench

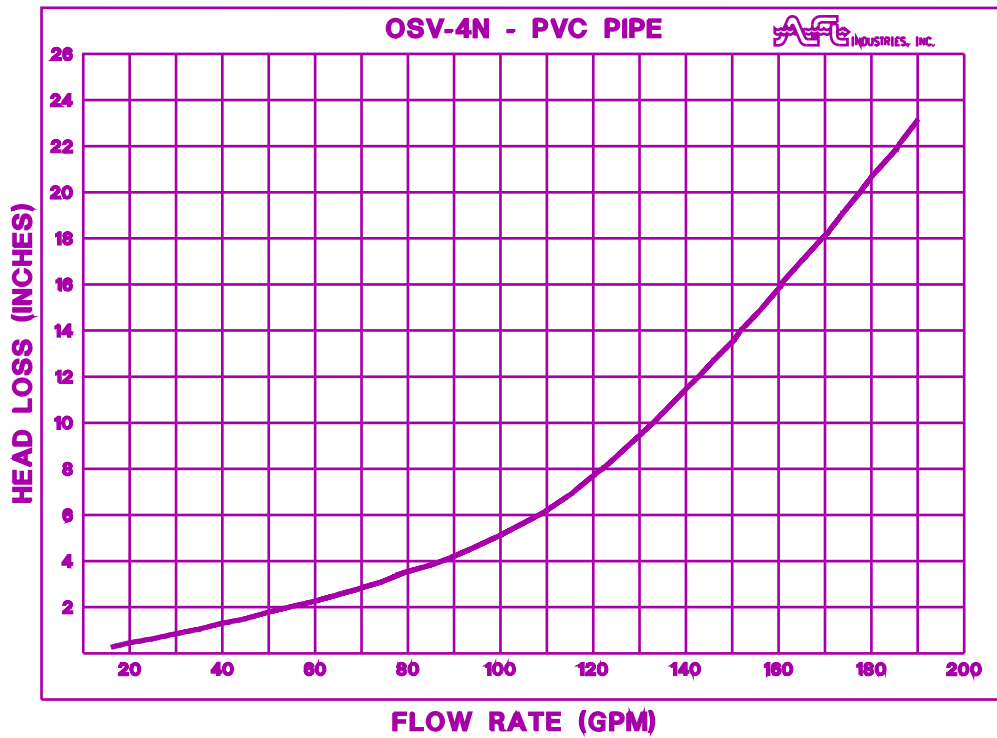
Figure: 2.01 OSV-4 HEAD LOSS VS. FLOW RATE

**NOTE:** For the valve to operate properly at required flow(s), the valve discharge pipe centerline must be below the liquid level at a distance equal to (or greater than) the associated head loss.

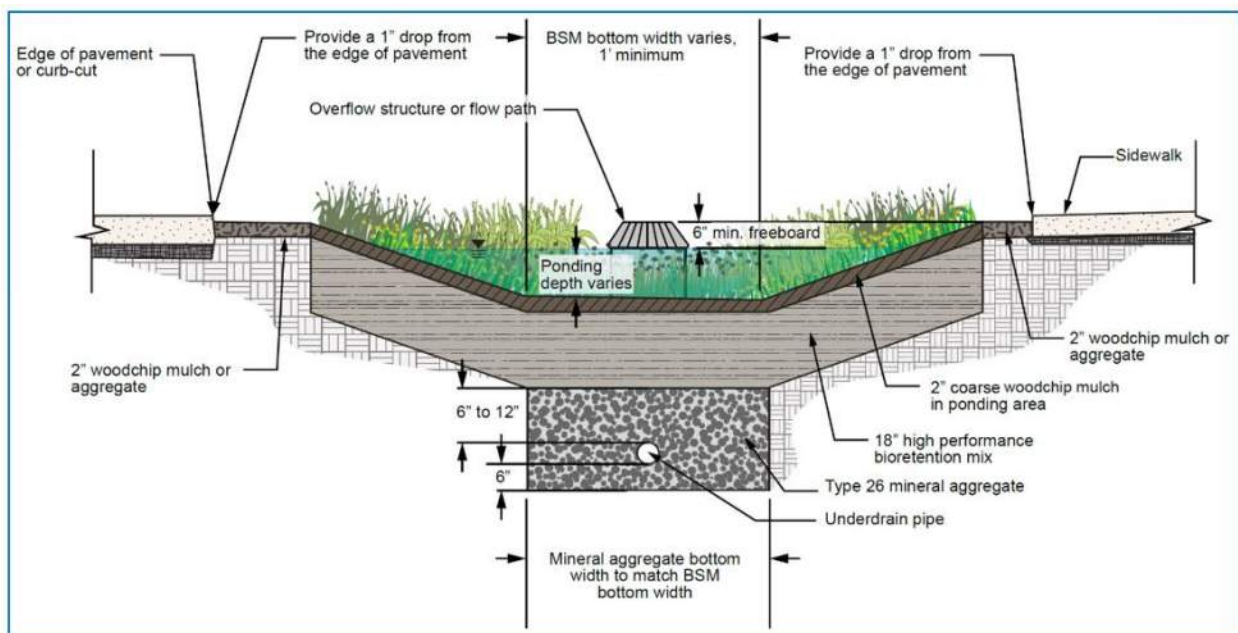
Figure 1. Typical Cross Section of Type 1 HPBSM
