Revised Geotechnical Engineering Study Report

Tumwater Brewery Planned Action EIS Tumwater, Washington

File No. 19967-001-01

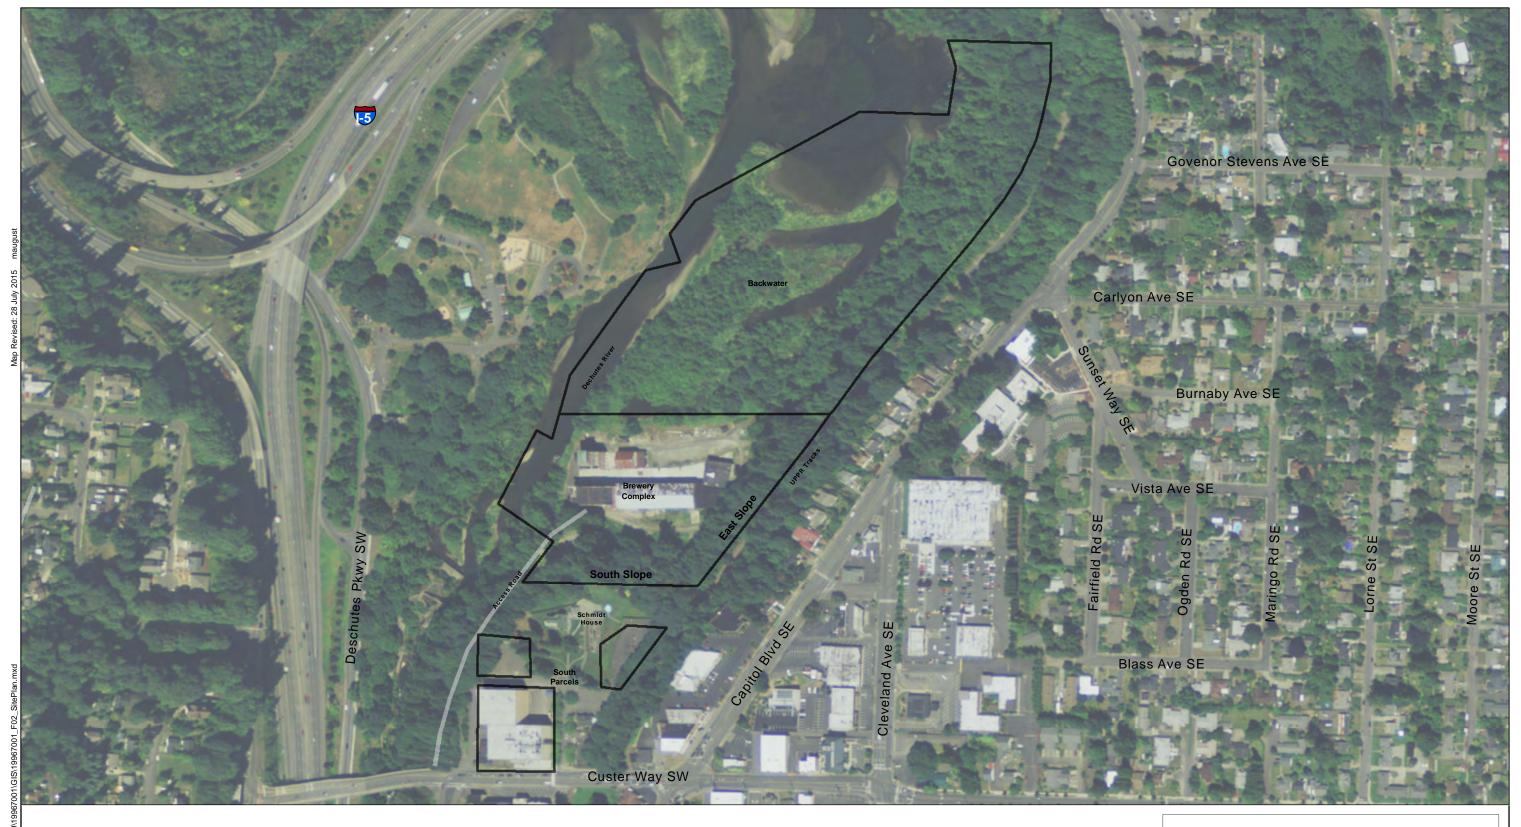
Figure 2

Figure 2. Site Plan

Below we provide a detailed discussion of our site reconnaissance procedure and observations. We present our discussion in three geographic areas: 1) brewery complex, 2) south parcels and access road, and 3) backwater. Figures 2 and 3 show relevant site features discussed in the following sections.

For the purposes of this report, the brewery complex is defined as the area surrounding the brewery buildings extending to the banks of the Deschutes River and backwater, and includes the east and south slopes as shown on Figures 2 and 3. South of the buildings, a steep slope rises up to the Schmidt House. East of the buildings a steep slope rises up to the UPRR tracks. The Deschutes River is to the west of the buildings and the backwater is to the north of the buildings. Below we describe surface conditions observed near the brewery buildings, on the slopes and along the shoreline.

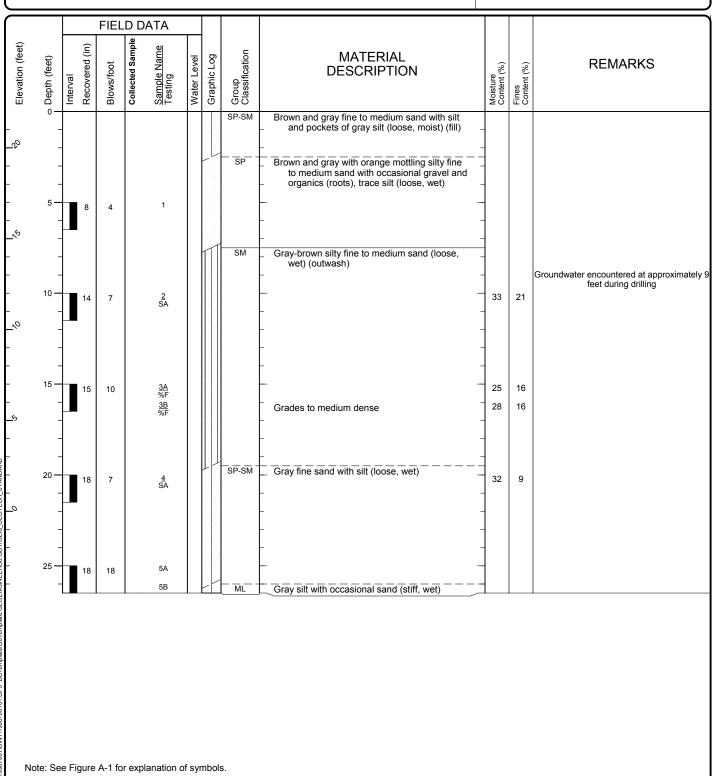
Log of Boring B-2

<u>Start</u> Drilled 5/26/2015	<u>End</u> 5/26/2015	Total Depth (ft)	26.5	Logged By Checked By	Driller Holocene Drilling Drilling Method Hollow-Stem Auger			m Auger	
Surface Elevation (ft) Vertical Datum		22 VD88		Hammer Data	Autohammer (lbs) / 30 (in) Drop Drilling Equipment Diedrich D-50			D-50	
Latitude Longitude				System Datum	N/A	Groundwate		Depth to Water (ft)	Elevation (ft)
Notes:							Se	e remarks

Explorations completed in the Brewery Complex portion of the site include borings B-1 through B-4 and CPT-1 and CPT-2 and CPT-2 were pre-drilled to depths of about 6 and 10 feet bgs, respectively. At the locations explored, soils generally encountered fill overlying native soils underlain by bedrock. The fill consisted of sand and gravel materials in a loose to medium dense condition extending to depths between 1-1/2 feet and 7 feet bgs. Below the fill, the native soils consist of sand, sand with silt, silty sand in a very loose to medium dense condition and very soft to stiff silt. Bedrock was encountered in boring B-4 and CPT-1 and CPT-2 at depths of about 21 feet, 16 feet, and 24 feet, respectively.

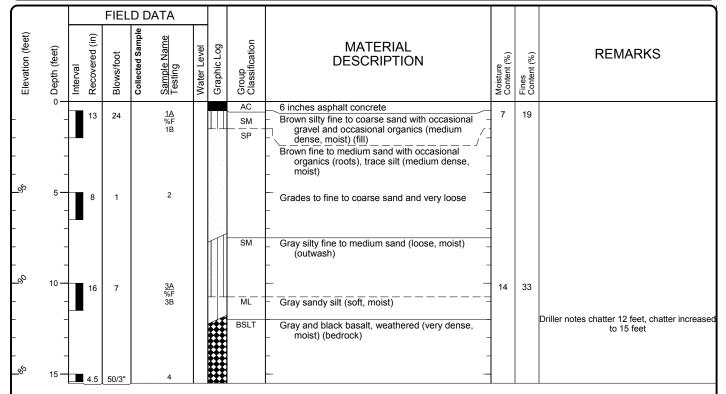
Log of Boring B-7

Sta Drilled 5/27/	<u>End</u> 5/27/2015	Total Depth (ft)	15.5	Logged By Checked By	Driller Holocene Drilling	Drilling Method			
Surface Elevar Vertical Datum		00 VD88		Hammer Data	Autohammer (lbs) / 30 (in) Drop Drilling Equipment Diedrich D-50			0	
Latitude Longitude				System Datum	N/A	Groundwate		Depth to Water (ft)	Elevation (ft)
Notes:							None	encountered

Explorations completed on the bench and along the access road include borings B-5, B-6, and B-7 which extended to depths of 26 feet, 12 feet, and 16 feet, respectively. At the locations explored fill consisting of medium dense sand with silt and silty sand extended to about $1\frac{1}{2}$ to 3 feet bgs. Below the fill very loose to medium dense sand, sand with silt, and silty sand extended to depths between 12 feet and 25 feet bgs. All three borings terminated with refusal on bedrock.

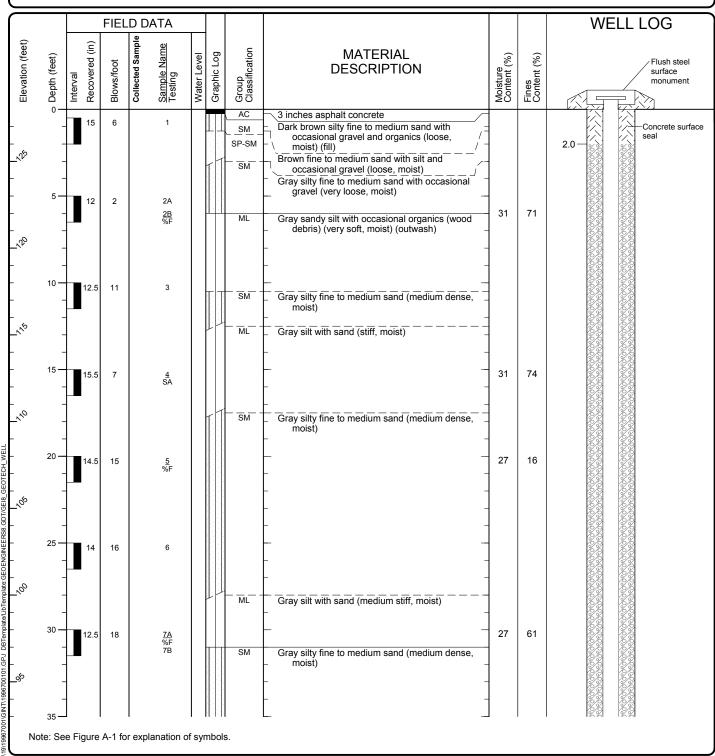
Log of Monitoring Well MW-1

<u>Start</u> Drilled 5/28/2015	<u>End</u> 5/29/2015	Total Depth (ft)	120.1	Logged By CRN Checked By	Driller Holocene Drilling		Drilling Hollow-Stem Auger			
Hammer Data	Autohai 140 (lbs) / 30			Drilling Equipment	7.12 () Non Nac motanea en e/20/20 to to a depti					
Surface Elevation (Vertical Datum	,	128 VD88		Top of Casing Elevation (ft)		(ft). Groundwater	Depth to			
Latitude Longitude				Horizontal Datum	N/A	<u>Date Measured</u> 5/29/2015	<u>Water (ft)</u> 72.6	Elevation (ft) 55.4		
Notes:

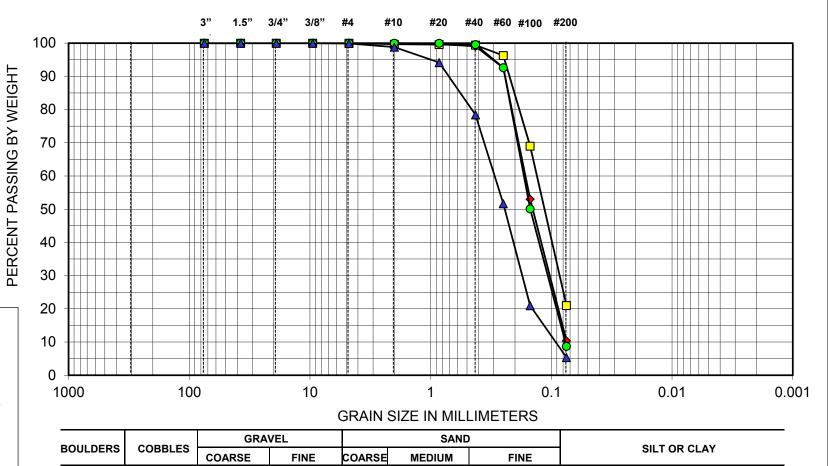
Figure A-10

SYMBOL	EXPLORATION NUMBER	DEPTH (ft)	LABORATORY SOIL CLASSIFICATION
•	B-1 B-2 B-2 B-3	25 10 20 15	Poorly graded sand with silt (SP-SM) Silty sand (SM) Poorly graded sand with silt (SP-SM) Poorly graded sand with silt (SP-SM)

Soil samples obtained during our explorations were transported to GeoEngineers' laboratory for further examination and testing. Representative soil samples were selected for laboratory tests to evaluate the pertinent geotechnical engineering characteristics and to confirm or modify field classifications. Our geotechnical testing program included grain-size analyses, percent fines determination, and moisture content determination. Details of our laboratory testing program are presented in Appendix A.

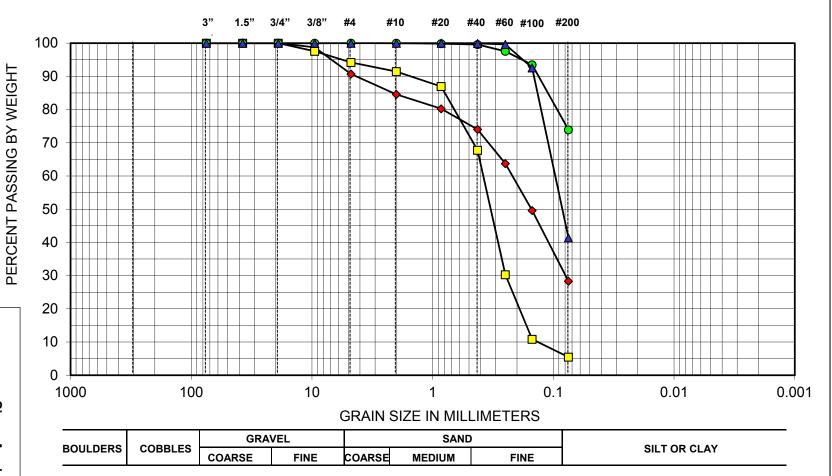
Figure A-11

SYMBOL	EXPLORATION NUMBER	DEPTH (ft)	LABORATORY SOIL CLASSIFICATION
•	B-4 B-5 B-8 B-8	15 10 15 45	Silty sand (SM) Poorly graded sand with silt (SP-SM) Silt with sand (ML) Silty sand (SM)

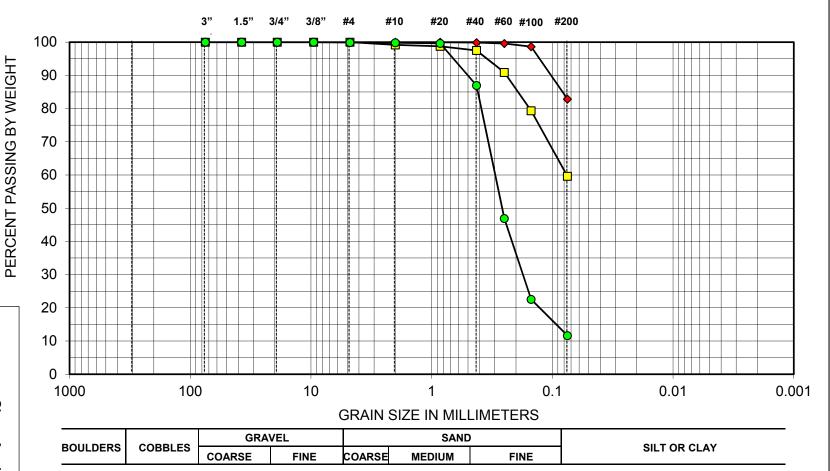
SYMBOL	EXPLORATION NUMBER	DEPTH (ft)	LABORATORY SOIL CLASSIFICATION
•	B-8 B-8 B-8	70 90 95	Silt with sand (ML) Sandy silt (ML) Poorly graded sand with silt (SP-SM)

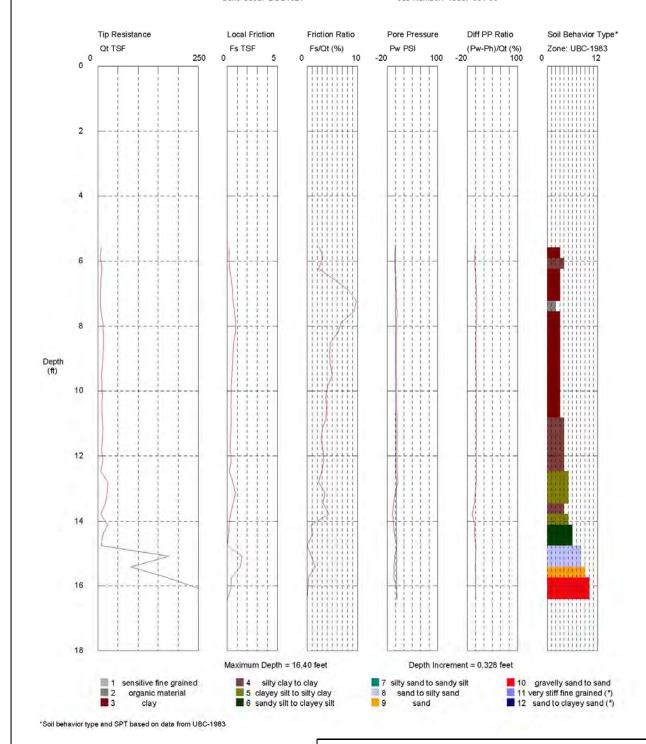
C-1 Coneplot

Operator: SAM Sounding: P-1 Cone Used: DSG1021 CPT Date/Time: 3/8/2011 11:35:43 AM Location: OLYMPIA BREWHOUSE Job Number: 19967-001-00

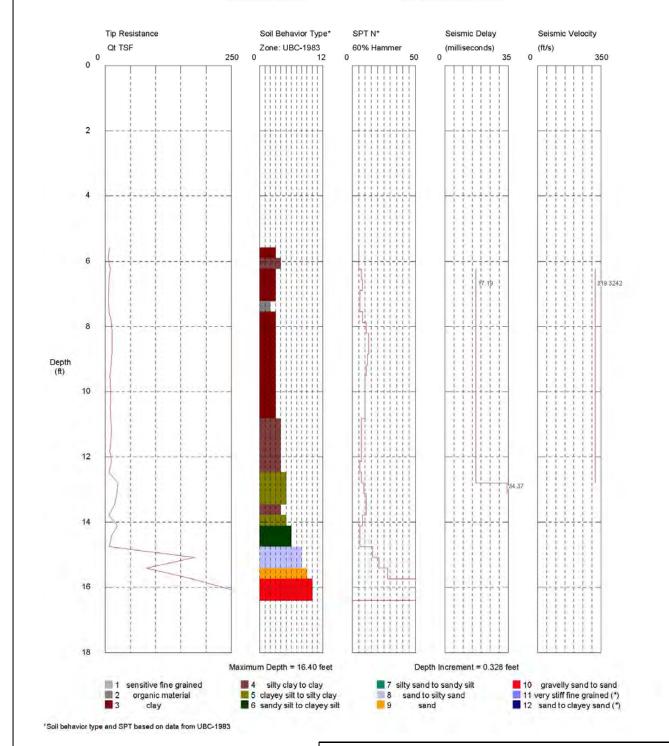
C-1 Seismic Coneplot

Operator: SAM Sounding: P-1 Cone Used: DSG1021 CPT Date/Time: 3/8/2011 11:35:43 AM Location: OLYMPIA BREWHOUSE Job Number: 19967-001-00

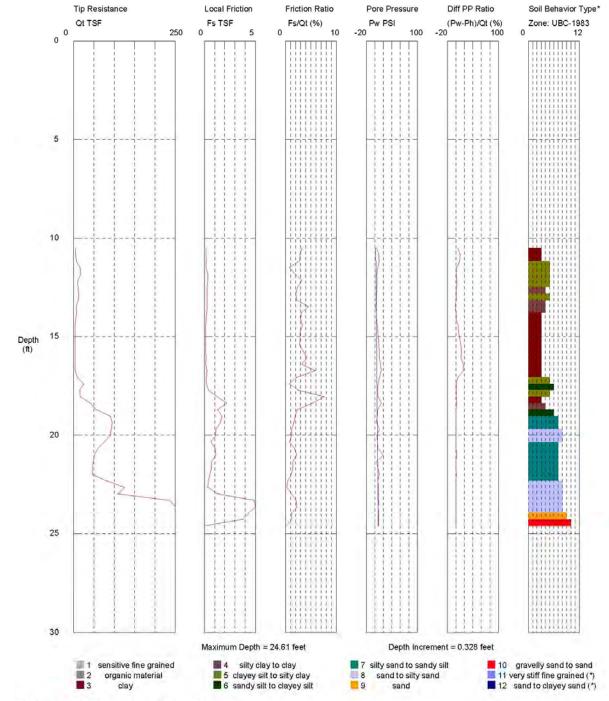
C-2 Coneplot

Operator: SAM Sounding: P-3 Cone Used: DSG1021 CPT Date/Time: 3/8/2011 2:28:01 PM Location: OLYMPIA BREWHOUSE Job Number: 19967-001-00

'Soil behavior type and SPT based on data from UBC-1983

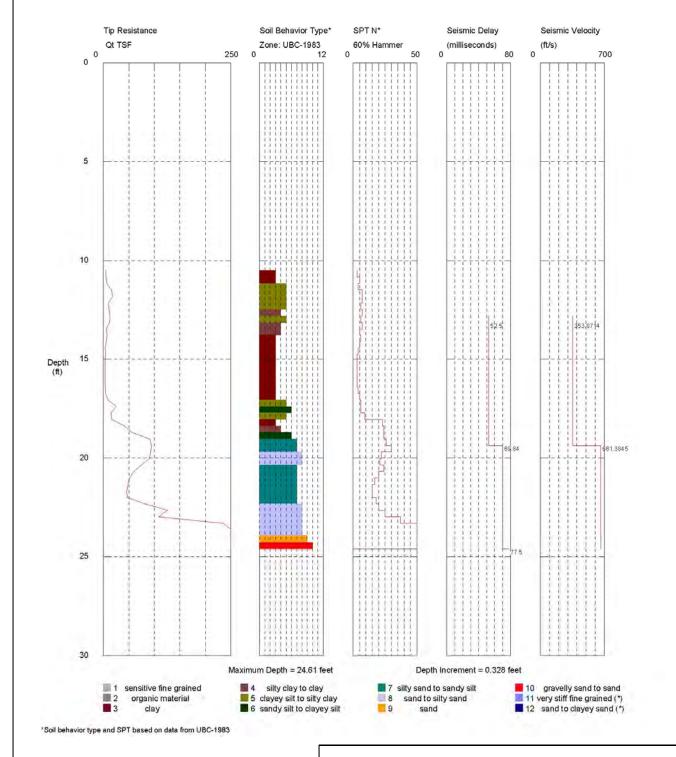
C-2 Seismic Coneplot

Operator: SAM Sounding: P-3 Cone Used: DSG1021 CPT Date/Time: 3/8/2011 2:28:01 PM Location: OLYMPIA BREWHOUSE Job Number: 19967-001-00
